ARMY AVIATION TEST BOARD FORT RUCKER ALA  
PRODUCT IMPROVEMENT TEST OF MAST, P/N 204-040-366-7, IN THE UH---ETC(U)  
DEC 65

DEPARTMENT OF THE ARMY  
UNITED STATES ARMY AVIATION TEST BOARD  
Fort Rucker, Alabama 36362

SUBJECT: Letter Report of Product Improvement Test of Mast,  
P/N 204-040-366-7, in the UH-1D Helicopter, USATECOM  
Project No. 4-5-0151-04

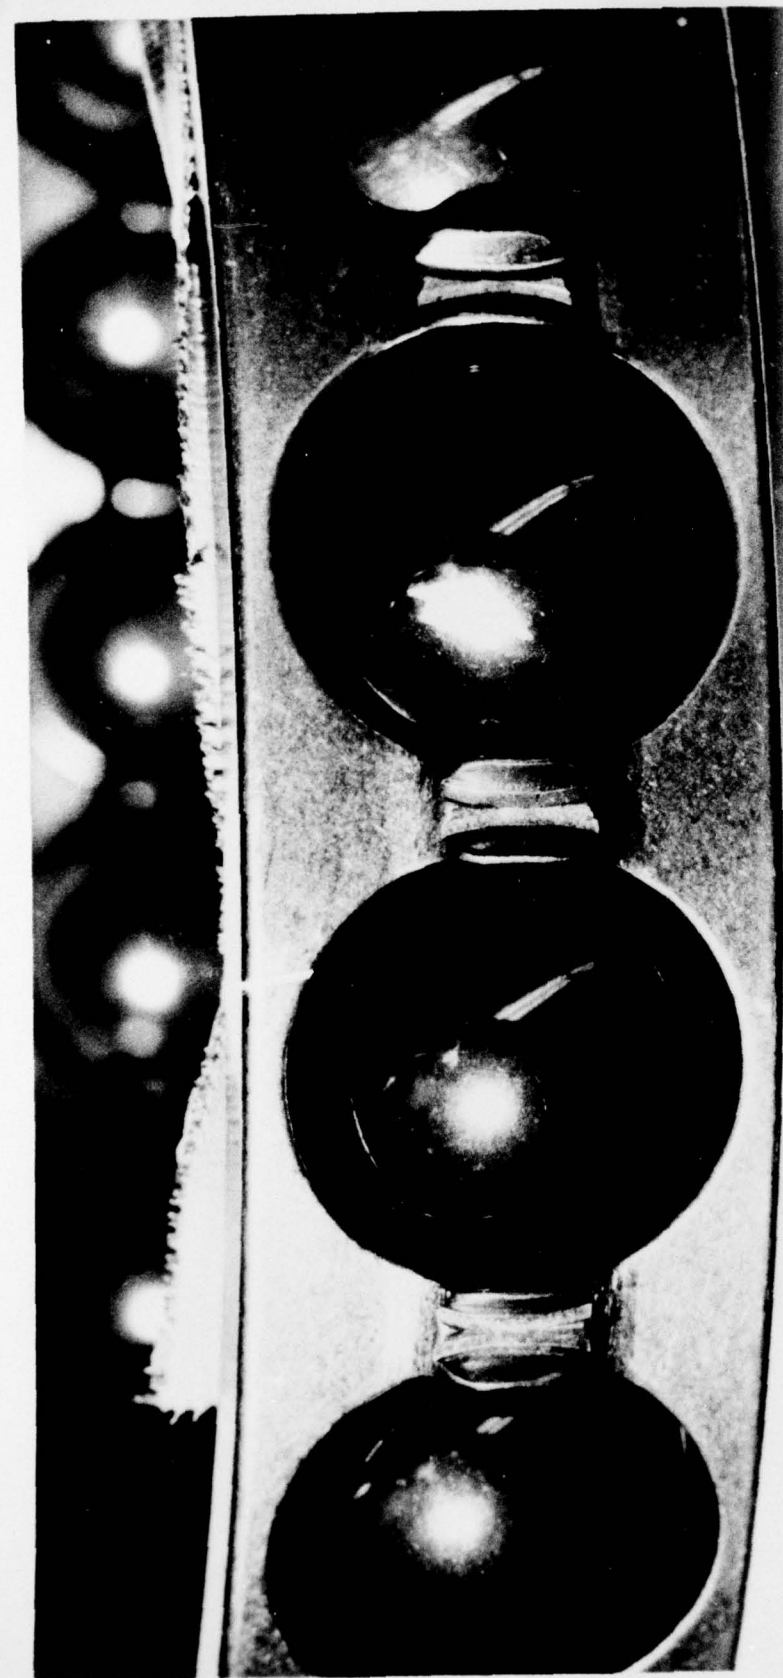
Photograph 1

(1) The first ball to the right of the "S/N 10" mark had a line running the entire circumference of the ball. A definite roughness existed at this line. Further visual inspection revealed that most of the balls had this line visible and detectable by touch to varying degrees (photograph 1, inclosure 1). The circumferential line of the balls appears to be a parting line formed during the impression-die-forging.

c. Reference the discrepancy reported in paragraph 4a(1) above. The manufacturer stated that they were unable to determine whether the balls were formed by impression-die-forging or skew rolling since the subcontractor considered this proprietary information. The detection of this line by feel was an abnormality which was not mentioned in the manufacturer's report.

b. The helicopter manufacturer be requested to perform a further study of the test bearing assembly, S/N 10, to determine whether the discrepancies not noted by the manufacturer's report (such as the feel-detectable circumferential lines and scratches or grooves on the balls) are characteristic of a design deficiency and that the cause of the discrepancies be determined.

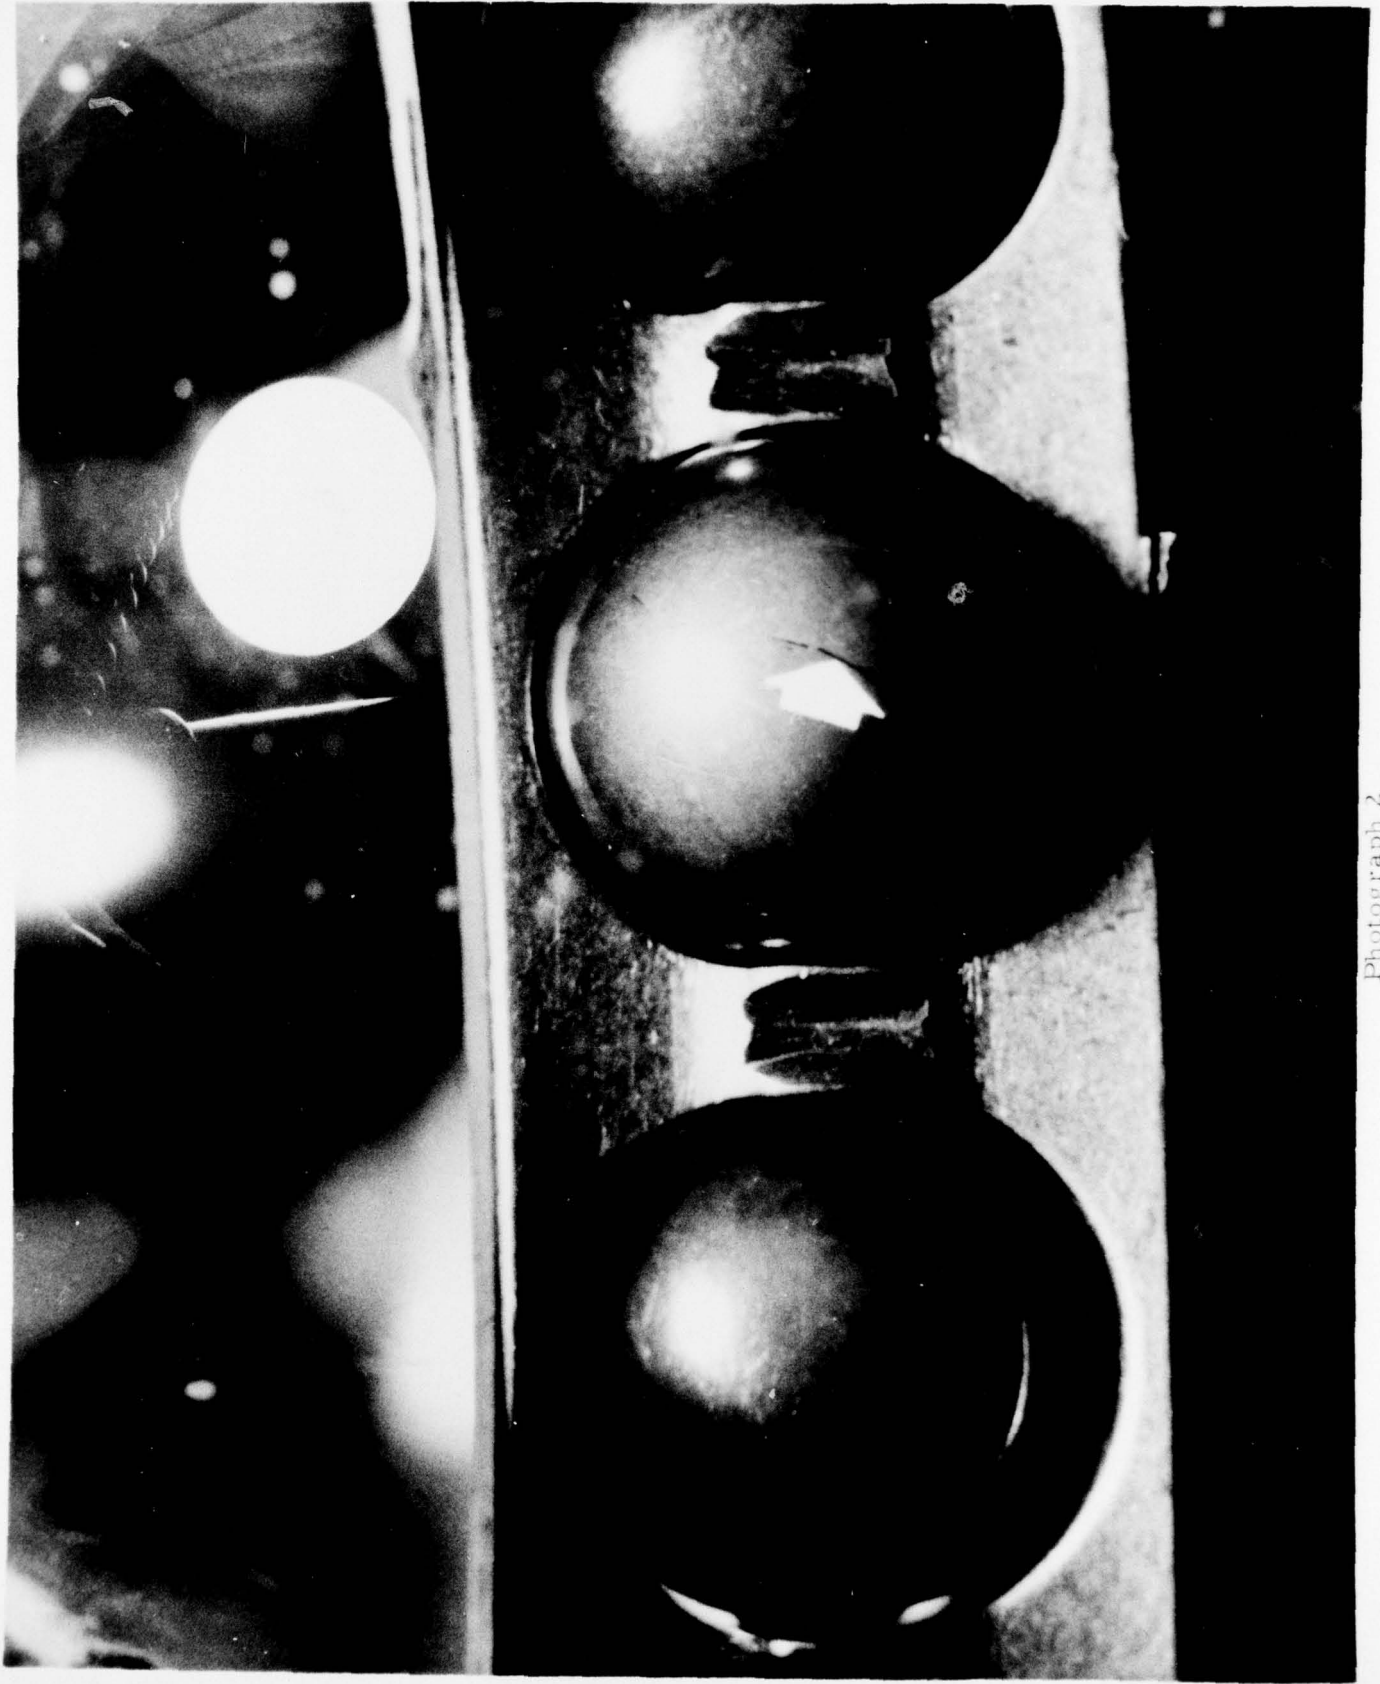
Photograph 2

(2) The second ball to the left of the "S/N 10" mark had a 3/16-inch long groove or scratch on it (photograph 2, inclosure 1). The groove or scratch could be seen and felt. In addition, grooves or scratches could be seen and felt on several of the other balls (photograph 3, inclosure 1). The grooves or scratches varied in length up to 3/16 inch. They appear to have been caused by metal particles or other foreign materials.

d. The discrepancies reported in paragraphs 4a(2) and 4a(4) above were not mentioned in the manufacturer's report.

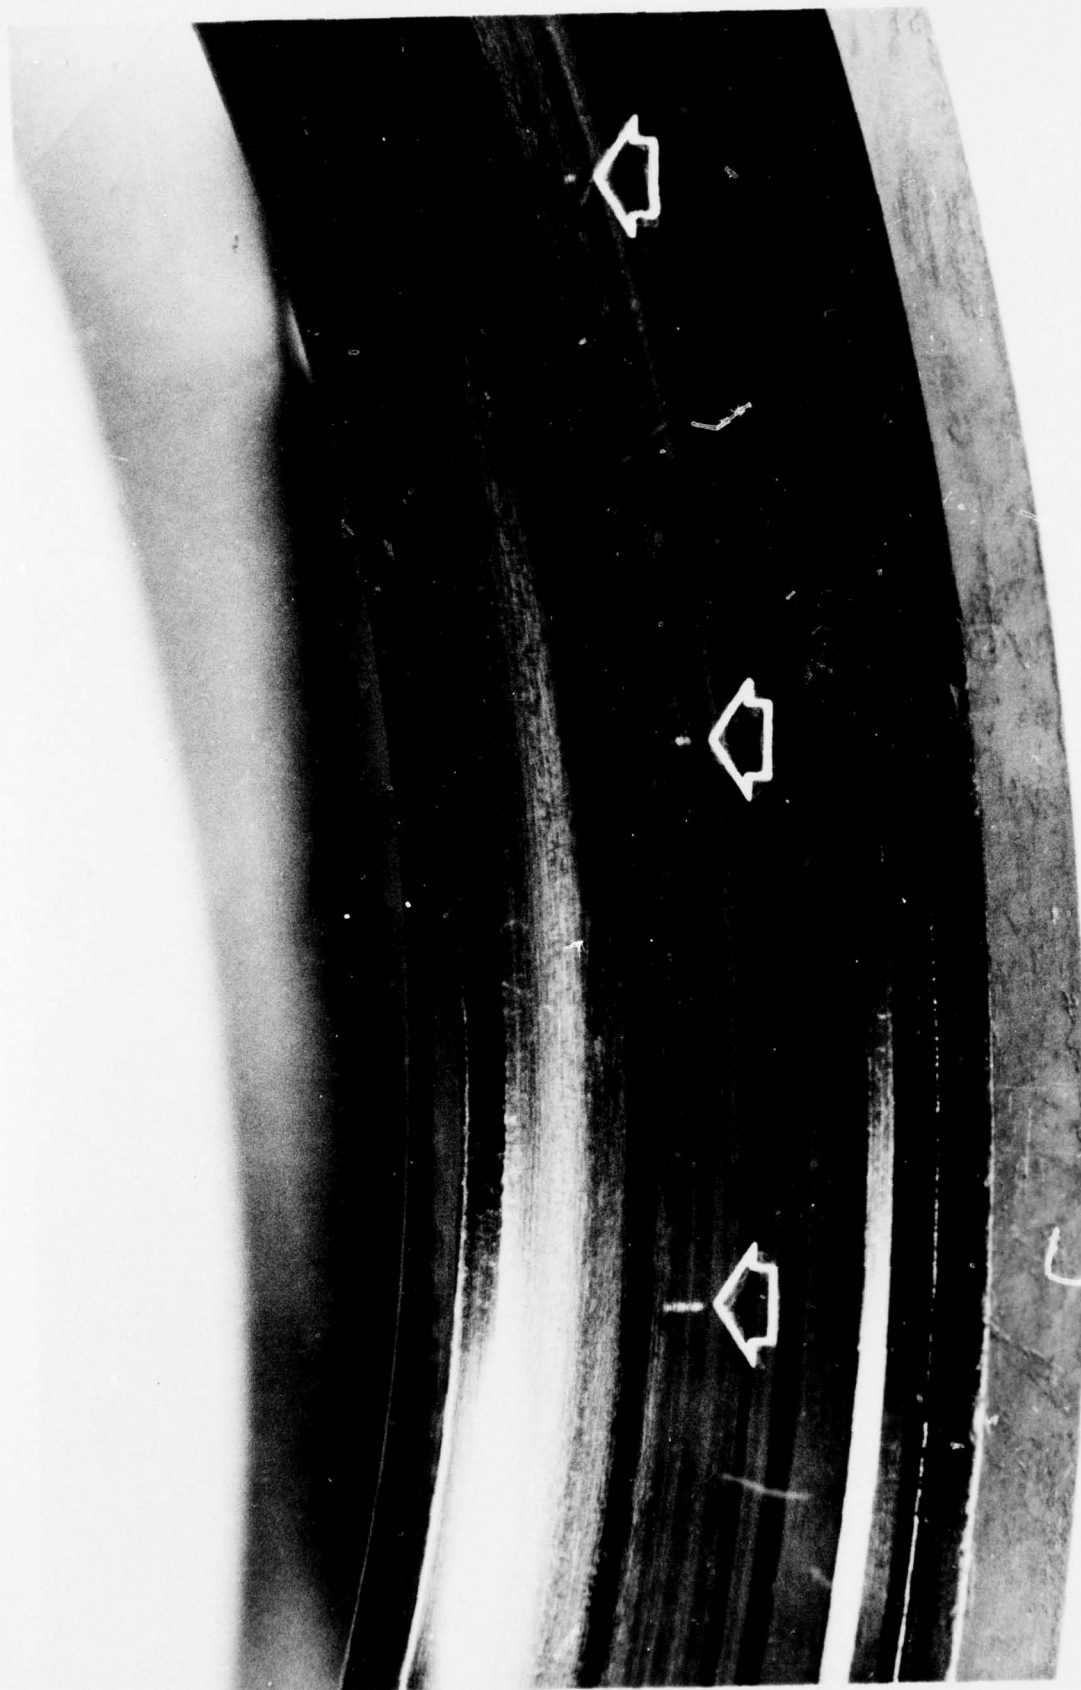
Photograph 4

(4) The outer race of the bearing had the following marks present (photograph 4, inclosure 1).

(a) A mark perpendicular to the circumference of the race and located 3/4-inch to the left of the "F" in the manufacturer's trademark. This mark was approximately 3/32-inch in length and was located in the center of the outer race.

(b) A mark perpendicular to the circumference of the race and directly under the "a" in the manufacturer's trademark. The mark was 1/32-inch long and was located in the center of the outer race.

(c) A mark perpendicular to the circumference of the race and 5/16-inch to the left of the "U" in "USA." The mark was 1/16-inch long and was located in the center of the outer race.
